Focus on failures: Overlooking the obvious can be costly

Tom Terlizzi

GM Systems LLC
Kings Park, N.Y. 11754
gmsystems.com

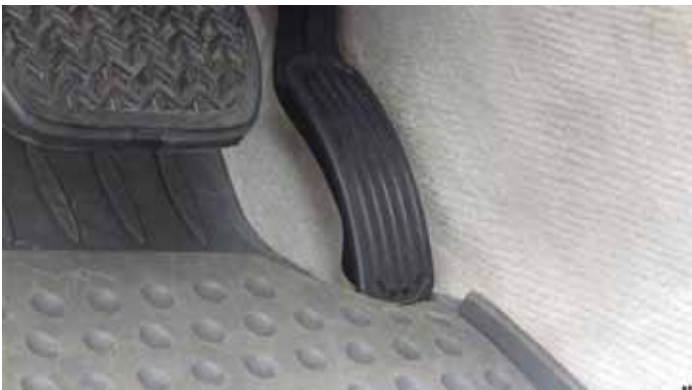
Stuck accelerator pedals (believed caused by Toyota floor mats) led to a recall of nearly 15 million Toyotas. (Wikipedia)
